## field and playground master plan - soldiers point public school

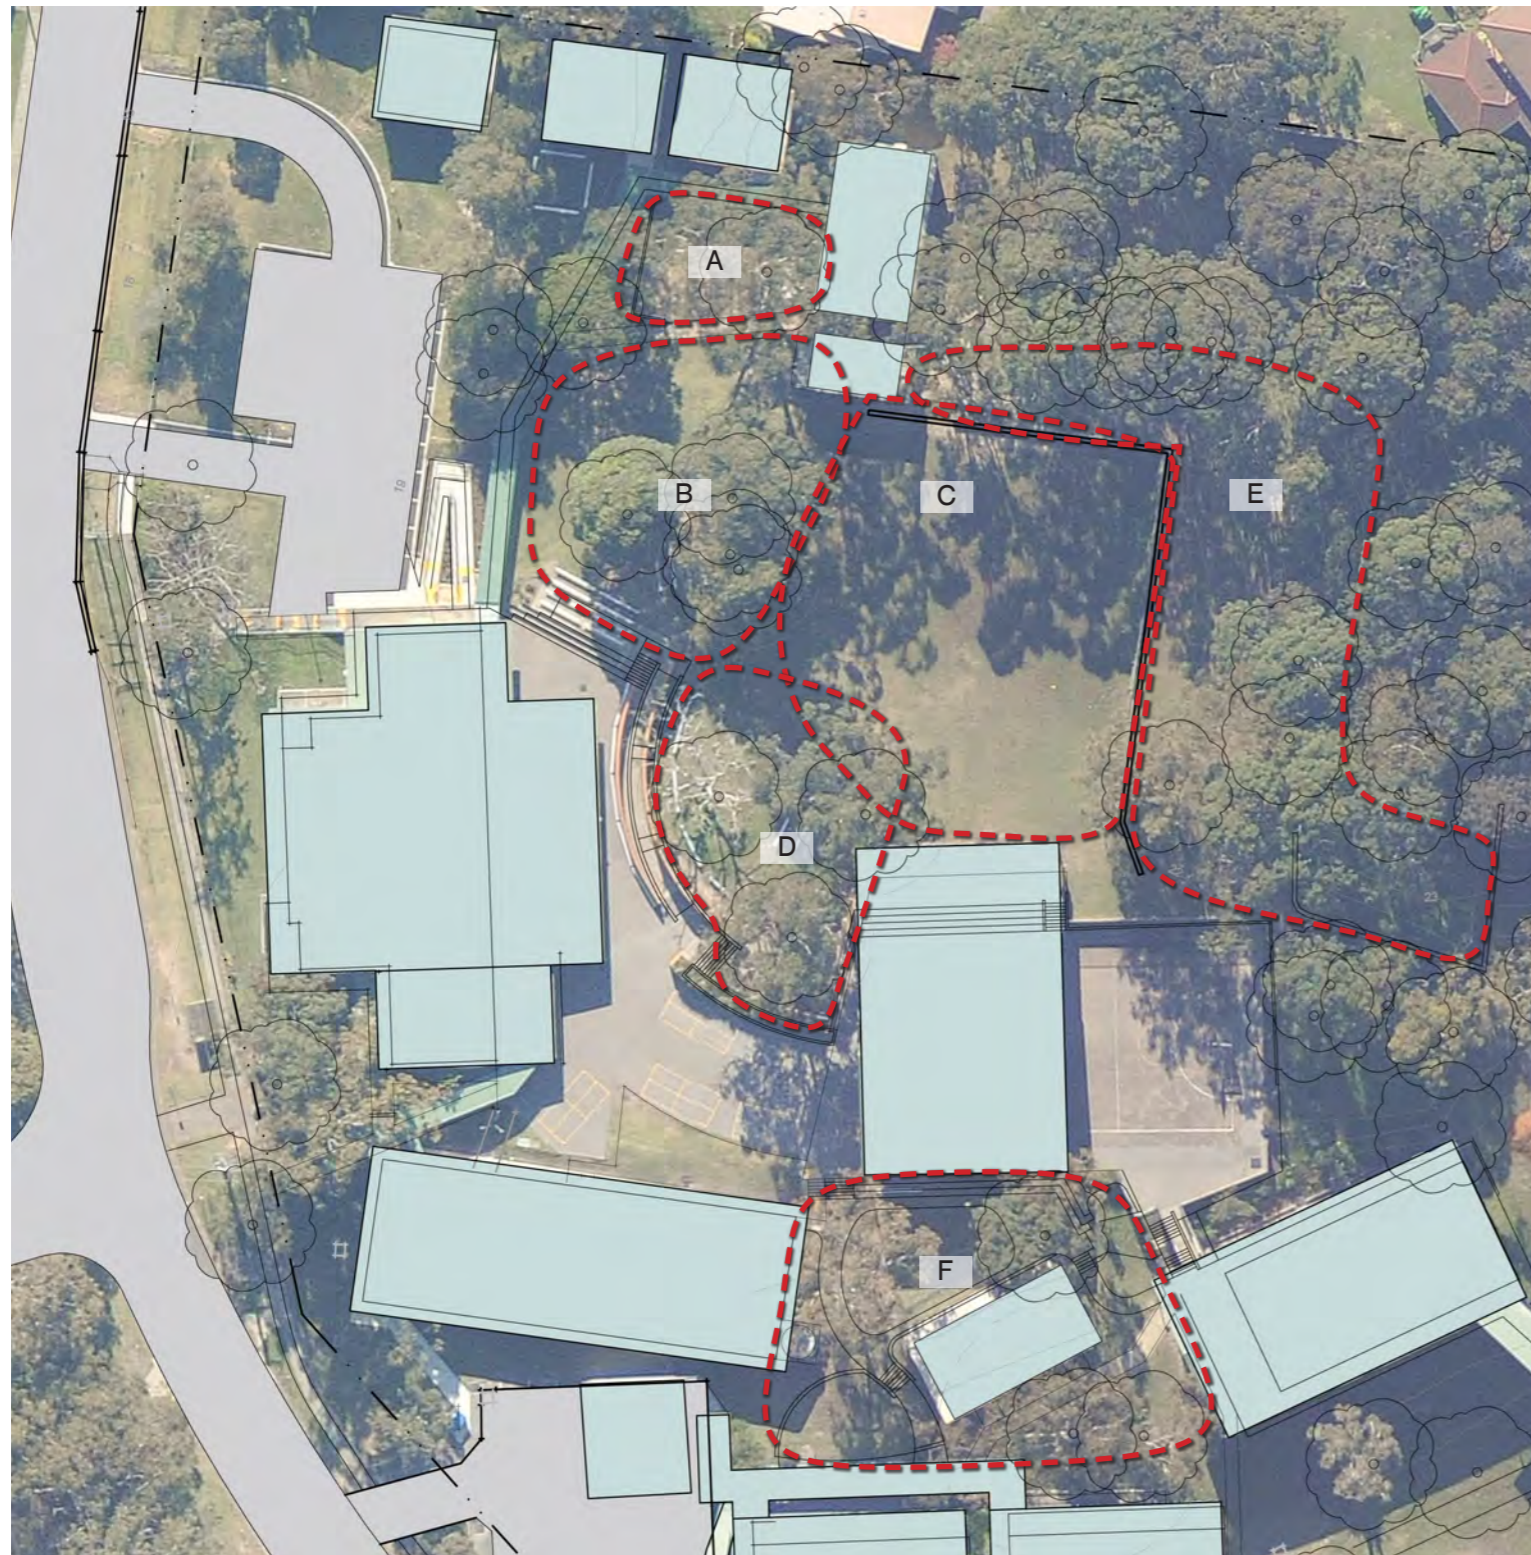
Existing vegetable garden with retaining wall to make level

- Existing trees with benches and picnic tables under
- excessive wear has removed grass from under trees
- tree roots are impacted from soil compaction

Field is waterlogged for extended periods due to ineffective drainage

Wooden retaining wall needs replacement

- Excessive wear from foot traffic across lawn
- grass has been worn away
- soil compaction will damage tree health

Vegetation is receding due to foot traffic and play activities

Erosion needs addressing

- Proposed playground area
- mature trees to be removed
- large level changes
- phased construction with removal of library
